A METALLURGICAL STUDY OF GERMAN AND ITALIAN AIRCRAFT ENGINE AND AIRFRAME PARTS

THE AERO COMPONENTS SUB-COMMITTEE
of the
TECHNICAL ADVISORY COMMITTEE
to the
SPECIAL AND ALLOY STEELS COMMITTEE

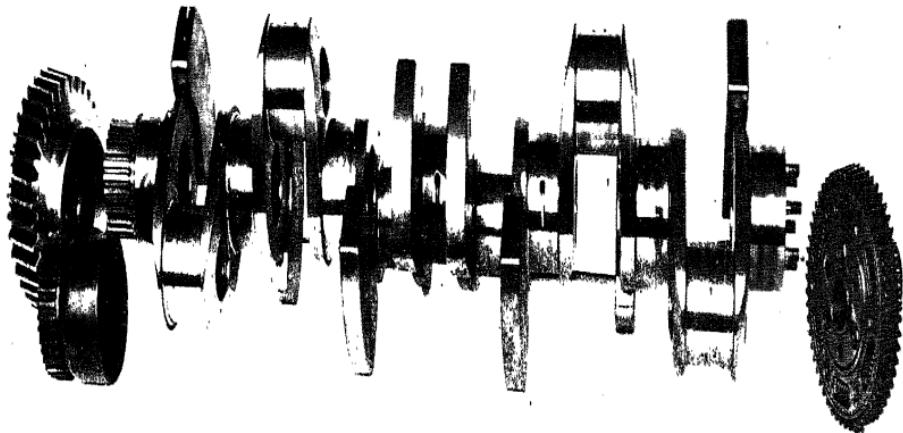
Fig. 2.—Mercedes-Benz D.B. 601A.

Report No. 19.—Mercedes-Benz D.B. 601A (see Fig. 2).

In general, the surface finish and workmanship throughout were of a high order, and during the preliminary examination no fatigue flaws, cracks or defects were found. The centre journal of Report No. 19 showed severe overheating, probably owing to loss of lubrication, and the appearance of the pin of the Fiat crankshaft (Report No. 82) indicated heavy bearing pressures.

The balance weights attached to the Mercedes-Benz D.B. 601A and D.B. 601N crankshafts consisted of three pieces riveted together, and rather heavier in the last-mentioned crankshaft (compare Figs. 2 and 3). The pins and journals had been bored and chambered concentrically. Mild steel tubes had been fitted inside the pins of these two crankshafts, and end caps of similar material had also been fitted to the journals of the Mercedes-Benz D.B.

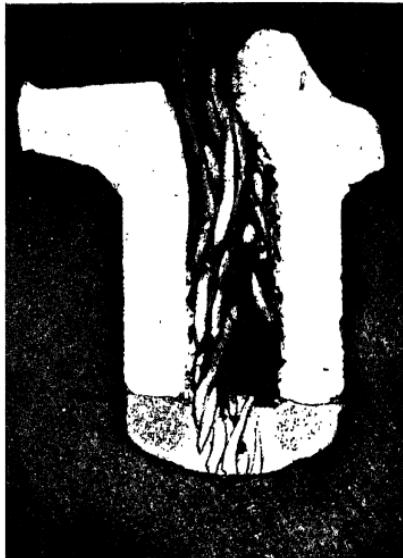
the method of attaching them to the cylinder is shown in Figs. 78 and 79. It was apparent that the wires had been brazed into a small brass plug, which was then put at the bottom of the

Fig. 79.—Section showing method of attaching thermocouple to cylinder. x 10.

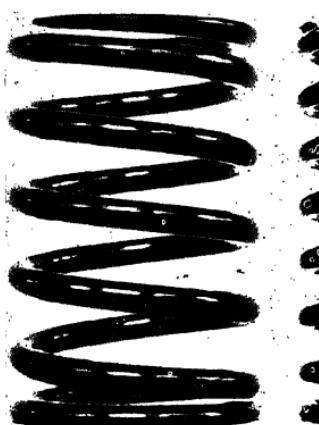
Fig. 82.—Bramo Fafnir 323P.

Of the springs examined after light etching only those of the Mercedes-Benz D.B. 601A (Report No. 18), and to a lesser extent the Bramo Fafnir 323P (Report No. 47)

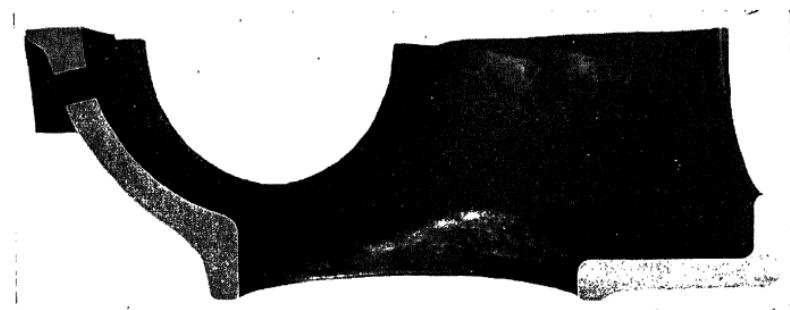
Fig. 162.—Structure of part of hub forging of Fiat A. 80R.C.41.

Both types of steel were representative of the basic electric-arc process, and both hubs had been made as forgings. In the case of the German one, the hub had first been made as a forged block and an axial hole had probably been punched or pierced during forging. The bulk of the metal from the interior had been removed by machining (see Fig. 160). Examination of the Italian hub showed that it had been made as two separate drop forgings to a contour closely following that of the finished article. (See Fig. 162.)
